DEPARTMENT OF TRANSPORTATION

Quality Assurance and Source Inspection

Contract #: 04-0120F4Cty: SF/ALA Rte: 80 PM: 13.2/13.9File #: 99.28**WELDING INSPECTION REPORT****Resident Engineer:**Siegenthaler, Peter**Address:** 333 Burma Road**City:** Oakland, CA 94607**Report No:** WIR-025707**Date Inspected:** 12-May-2011**Project Name:** SAS Superstructure**OSM Arrival Time:** 1500**Prime Contractor:** American Bridge/Fluor Enterprises, a JV**OSM Departure Time:** 300**Contractor:** Zhenhua Port Machinery Company, Ltd (ZPMC) Chanxing Island**Location:** Shanghai, China**CWI Name:** Li Pengfei**CWI Present:** Yes No**Inspected CWI report:** Yes No N/A**Rod Oven in Use:** Yes No N/A**Electrode to specification:** Yes No N/A**Weld Procedures Followed:** Yes No N/A**Qualified Welders:** Yes No N/A**Verified Joint Fit-up:** Yes No N/A**Approved Drawings:** Yes No N/A**Approved WPS:** Yes No N/A**Delayed / Cancelled:** Yes No N/A**Bridge No:** 34-0006**Component:** Tower Lift 6, 13AE**Summary of Items Observed:**

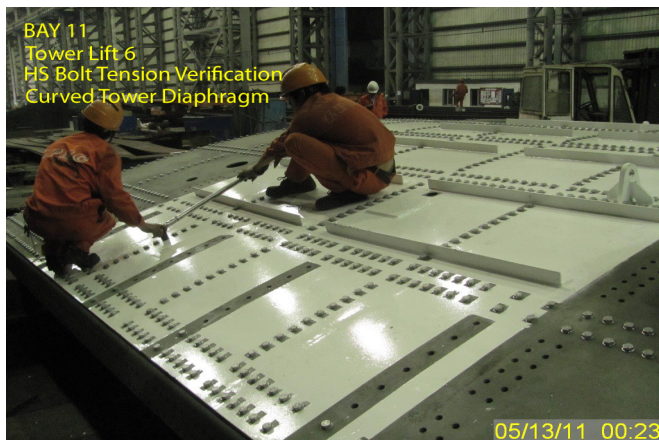
This QA Inspector witnessed the final bolt tension verification on bolts connecting the Curved Tower Diaphragm located on Tower Lift 6. This QA Inspector verified the bolt tension on a random basis and the results appeared to be in general compliance. The Inspection was performed against Notification No. 00683 dated May 11, 2011 and performed on May 13, 2011 00:30.

The following bolt sizes used on Curved Tower Diaphragm Lift 6 were:

M16 x 50 RC Lot # DHGM160050 and the final torque value established was 187 N-m.
M16 x 55 RC Lot # DHGM160040 and the final torque value established was 193 N-m.
M16 x 55 RC Lot # DHGM160040 and the final torque value established was 203 N-m.(Bolt Head)
